Callide Unit C4 turbine generator failure – 25 May 2021

Technical investigation summary

13 February 2024

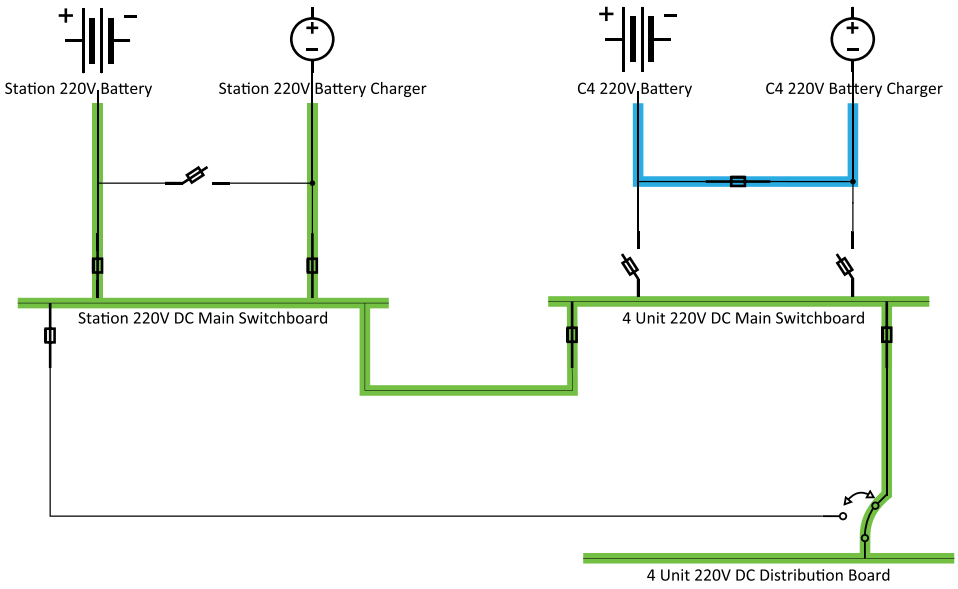
**Figure 3: DC configuration 24/05/2021 14:08. Colours denote different circuits.**
20:00	C4 220V battery was successfully charged and maintained in a fully charged state.

Time	Event
	24 May 2021
14:08	C4[1] 220V battery charger energised and returned to service in offline charging mode (connected to C4 battery only). Offline charging is required to ensure that the battery is fully charged prior to being returned to service.

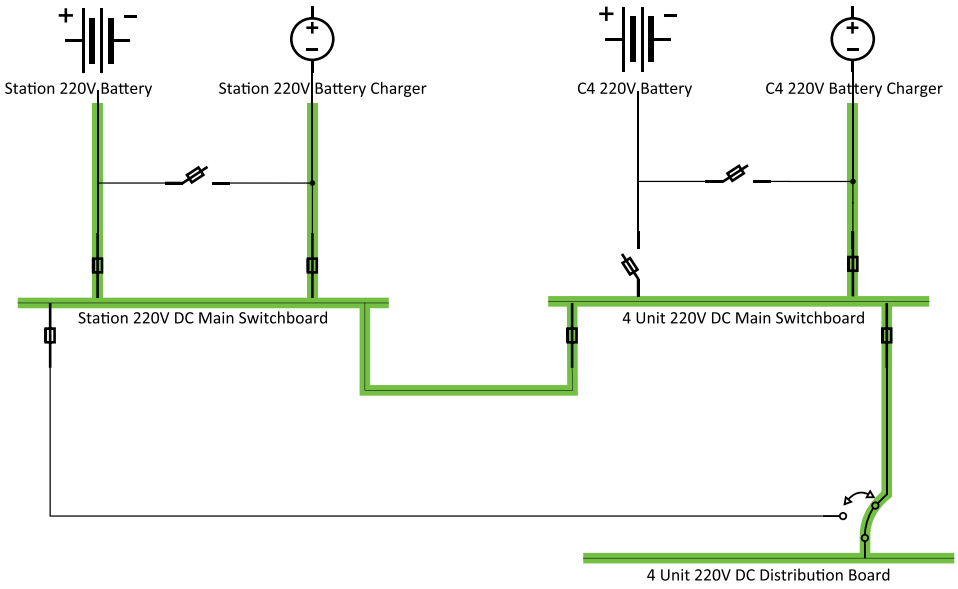
Figure 4: DC configuration 25/05/2021 13:32.

Time	Event
	25 May 2021
13:28	Switching commenced to return C4 battery charger to service into its typical configuration.
13:32	C4 offline battery charger circuit was opened and C4 220V battery charger was connected to Unit C4 220V DC Main Switchboard. Configuration as per Figure 4.

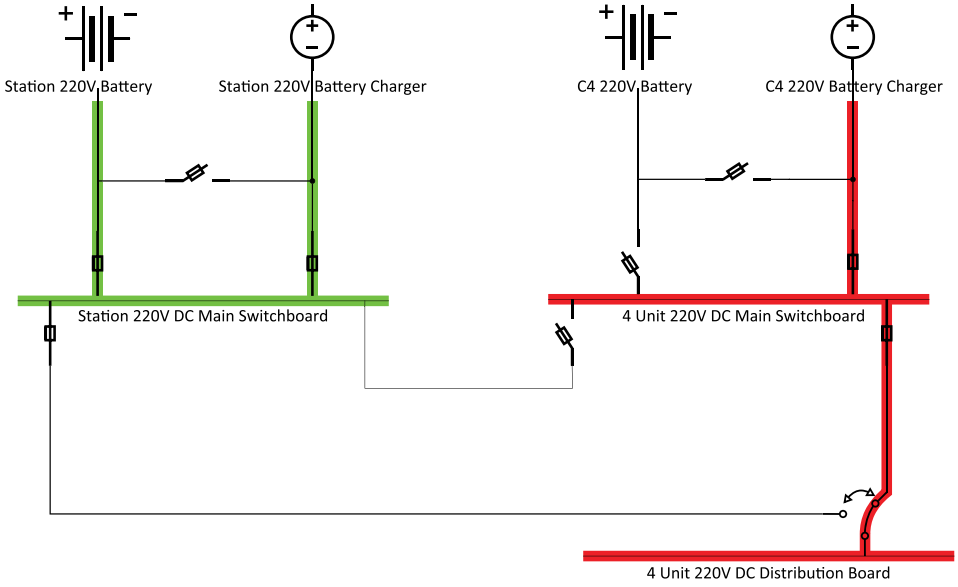
Figure 5: DC configuration 25/05/2021 13:34. Colours denote different circuits.

13:33	Unit C4 to Station Interconnector opened (initiating event), Unit C4 220V DC voltage decayed to zero volts.

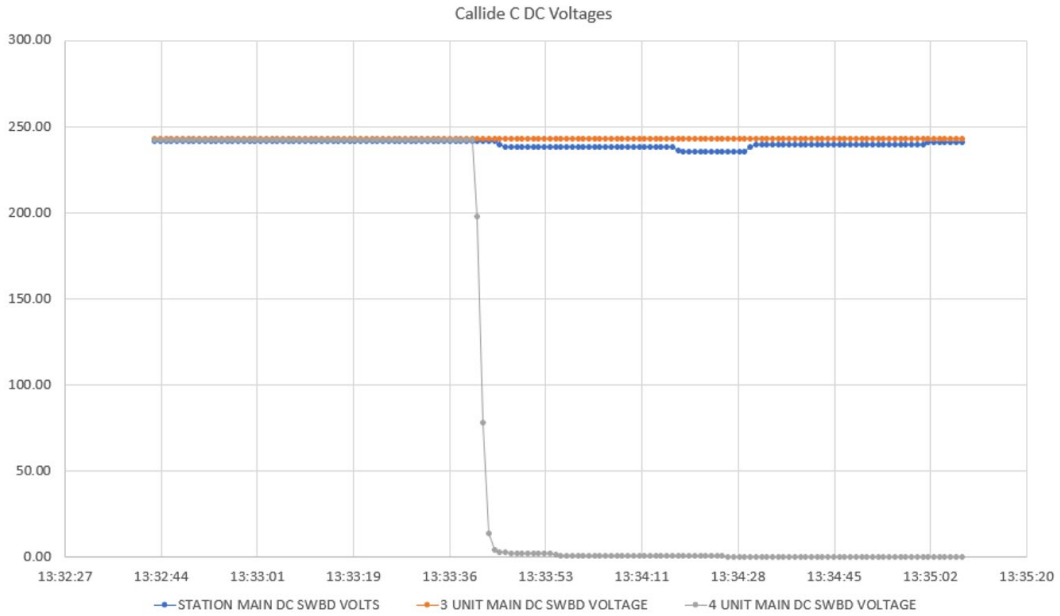
**Figure 6: DC voltage data**

Time	Event
13:33	Callide C DC voltage data is shown in Figure 6.

13:33 – 13:34	The decaying DC voltage on C4 triggered several events.
	• Turbine trip (closure of steam supply valves)
	• Excitation system trip
	• Failure of generator protection systems (X and Y, GCB)
	• Loss of 6.6kV and 415 auxiliary AC power supplies. This failure also initiated:
	  ○ Loss of turbine lubrication oil supply due to both AC and DC pumps having no power supply
	  ○ Loss of generator sealing oil supply due to both AC and DC pumps having no power supply
	  ○ Loss of control room screens
	  ○ Boiler tripping due to loss of major drives (fans, mills etc.) following the loss of 6.6kV supplies.

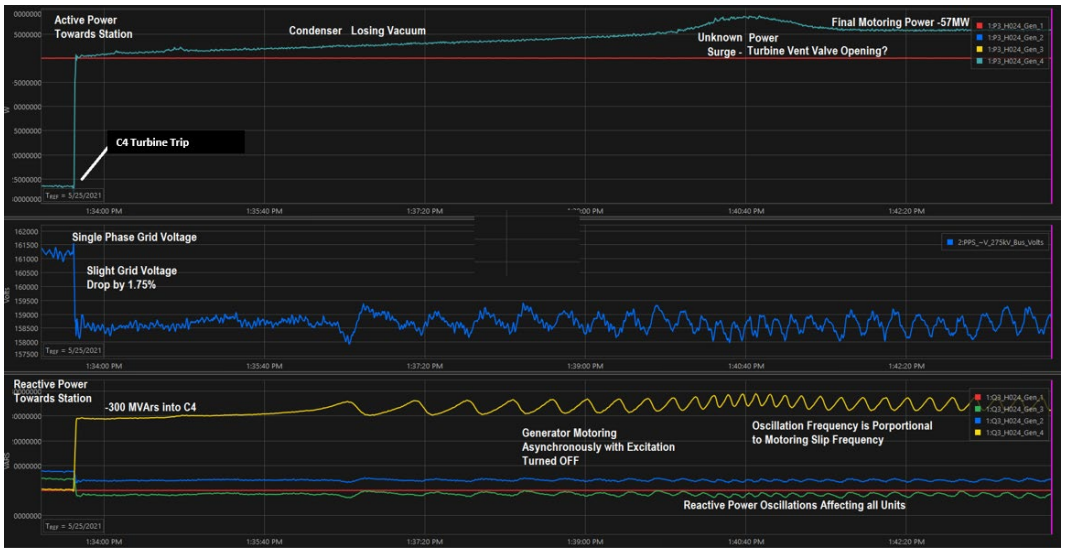
**Figure 7: Electrical trends – motoring event**

Time	Event
13:34 –14:05	The turbine tripped (closure of steam supply valves) due to the loss of AC and DC supplies to the governing oil system and resulted in the turbine/generator transitioning from generating power to absorbing power from the grid. This is called ‘motoring’. Motoring of a generator occurs when the generator is being driven by the system it is connected to, rather than driving the system itself. This can happen when the generator is not producing power but is instead consuming power from the system, which can lead to mechanical stress and potential damage to the generator. The generator was actively absorbing power from the grid, operating as an asynchronous motor, without any cooling systems functioning. The generator protection system has reverse power protection to disconnect the unit from the grid in this situation. However, due to the lack of DC power supply this protection was not able to operate. The turbine/generator was motoring at ~3,000 rpm without bearing lubrication due to the loss of both AC and DC power supplies. This generated excessive heat, melting the bearings and damaging the shaft, which resulted in shaft failures in several locations. The loss of AC and DC power supplies resulted in the loss of sealing oil supply and the release of hydrogen through the shaft seals resulting in an explosive mixture, which is likely to have been ignited by the elevated temperatures on the shaft, resulting in rapid hydrogen combustion/explosions.

14:06	The incident ceased when the generator suffered a significant electrical fault, the magnitude of which resulted in considerable damage to the generator transformer and in the de-energisation of the Calvale substation. The motoring ceased, the turbine generator stopped rotating and the incident reached its conclusion.

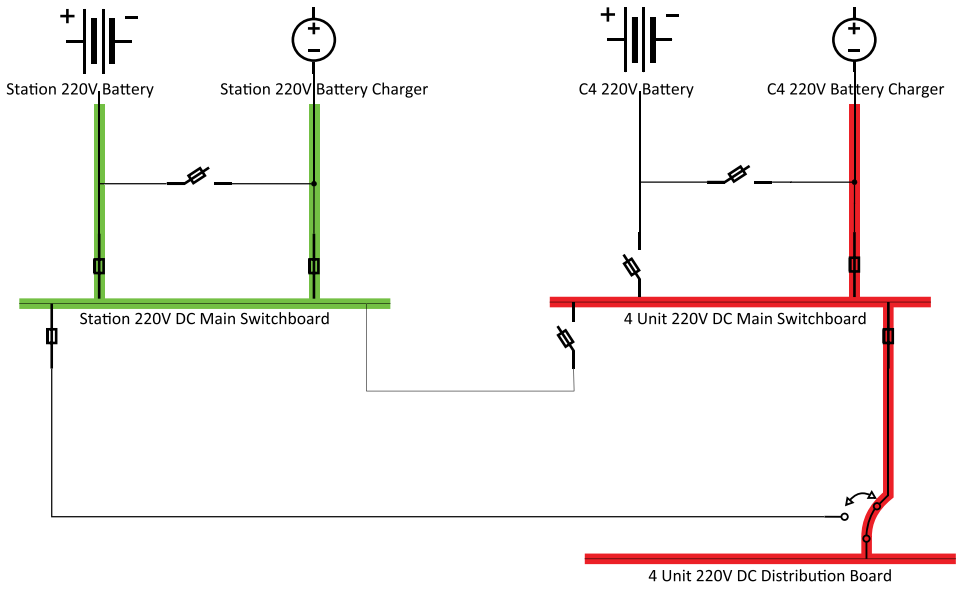
Figure 8: DC configuration 25/05/2021 13:34. Colours denote different circuits.

At the time of the Unit C4 incident, this interlock prevented the Unit C4 220V battery from being connected until the Station Interconnector was opened. This resulted in a circuit configuration as shown in Figure 8.

Therefore, following the opening of the Station Interconnector, Unit C4 220V DC Main Switchboard's sole source of supply was the Unit C4 220V battery charger.

In this configuration the reliability of the supply to the Unit C4 220V DC Main Switchboard is reduced to the reliability of the AC system powering the Unit C4 battery charger.

The key interlocking circuits have been modified to enable batteries to be paralleled but not battery chargers. This will ensure that during switching operations a battery can always be connected to provide necessary redundancy for critical protection circuits.

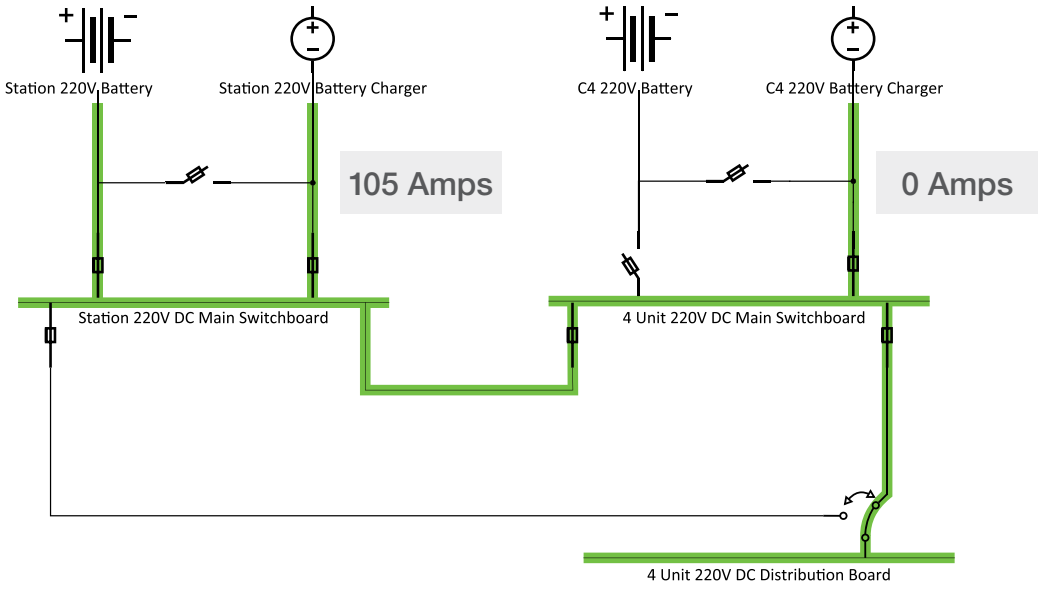
Figure 9: Battery charger current when operating in parallel – 25 May 2021 13:32

Despite the Unit C4 battery charger being set to a higher voltage than the Station battery, the actual Station and Unit C4 battery charger currents immediately prior to the opening of the Station Interconnector were as shown in Figure 9.

The Station 220V battery charger was providing all the load. On opening the Station Interconnector the Unit C4 220V battery charger had to detect the voltage drop and raise output to maintain the voltage. The Unit C4 220V battery charger failed to respond quickly enough to maintain the DC voltage before the loss of the AC supply. Once the AC supply was lost the Unit C4 220V battery charger had no opportunity to recover the voltage.

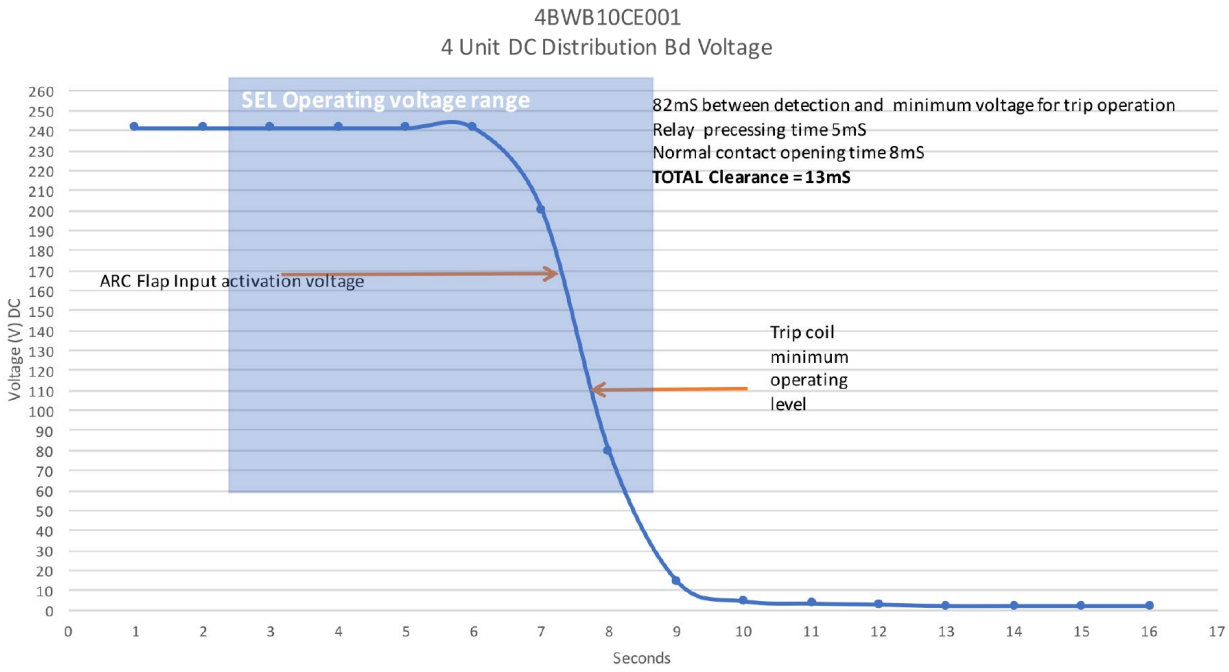
Figure 10: Unit C4 incident DC decay and arc flap activation

Figure 10 plots the DC voltage decay during the incident against the arc flap protection parameters. In this case, the manner in which the DC voltage decayed (gradually rather than immediately) was such that there was sufficient time and voltage for the protection relay to trip the 6.6kV circuit breaker.

The arc flap protection logic has been modified with electrical current conditioning such that it will only trip if the arc flap switch operates in association with a high electrical current. This will ensure the arc flap protection will be resilient to short term deviations in DC supply.

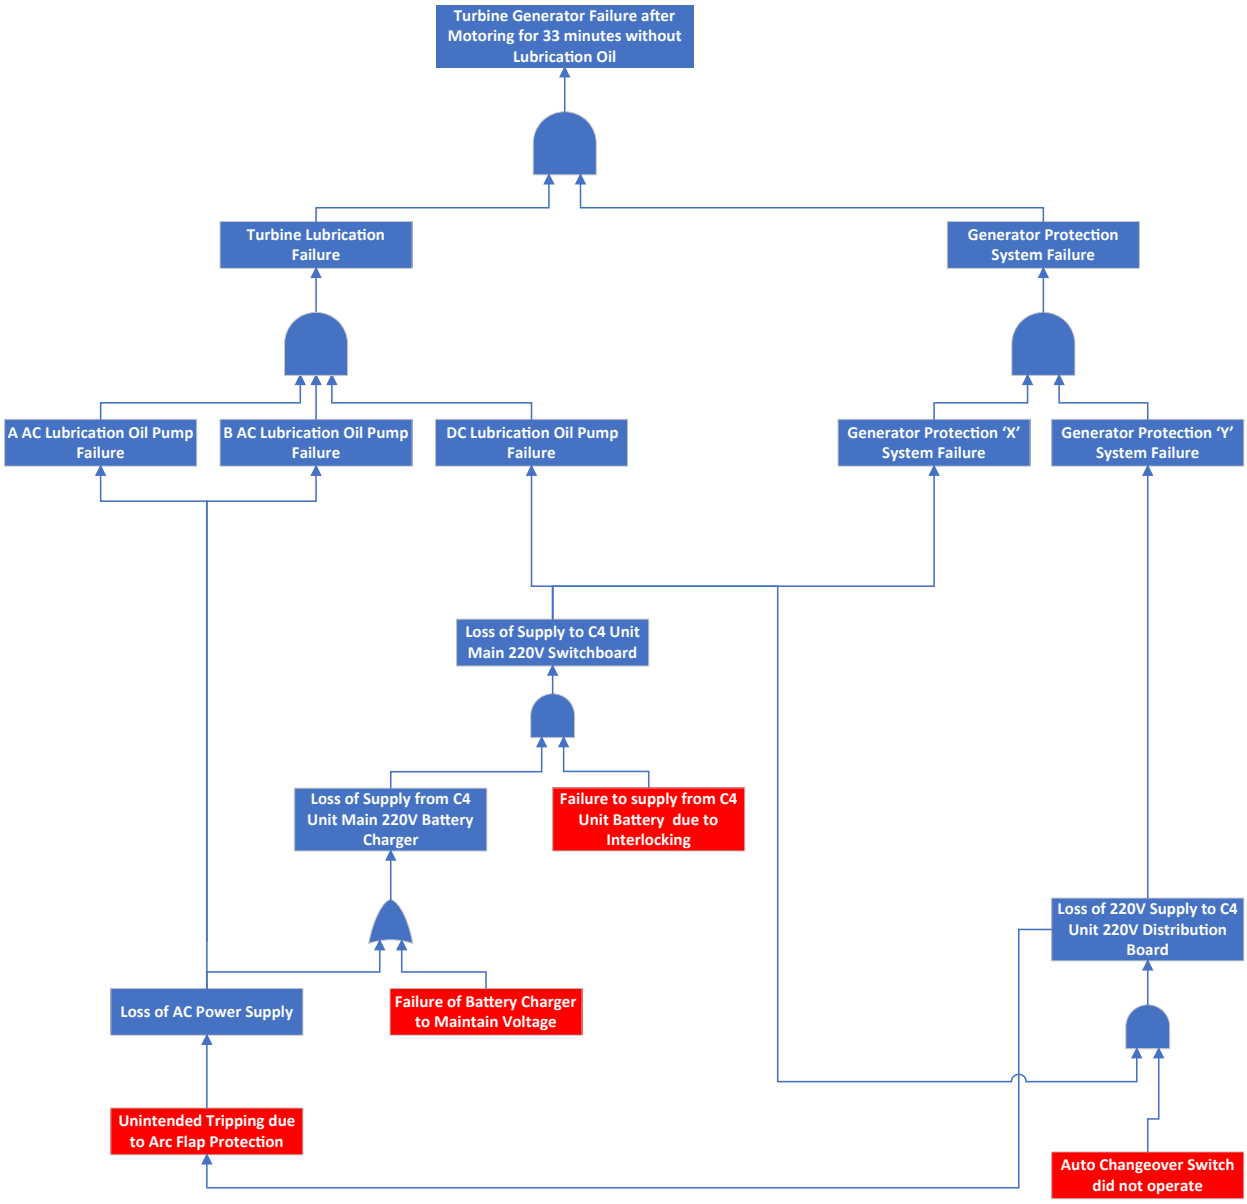
Figure 11: Unit C4 event simplified fault tree

The fault tree shows that the turbine generator failure required the failure of the entire turbine lubrication system and back-up systems:

The significant contributors to the Unit C4 incident (identified in red in Figure 11) have been identified, and are summarised below in order of importance:
